Capital Needs Assessment

PRELIMINARY REPORT

**Augustana Bishop Curtis
Congregate**

December 29, 2023

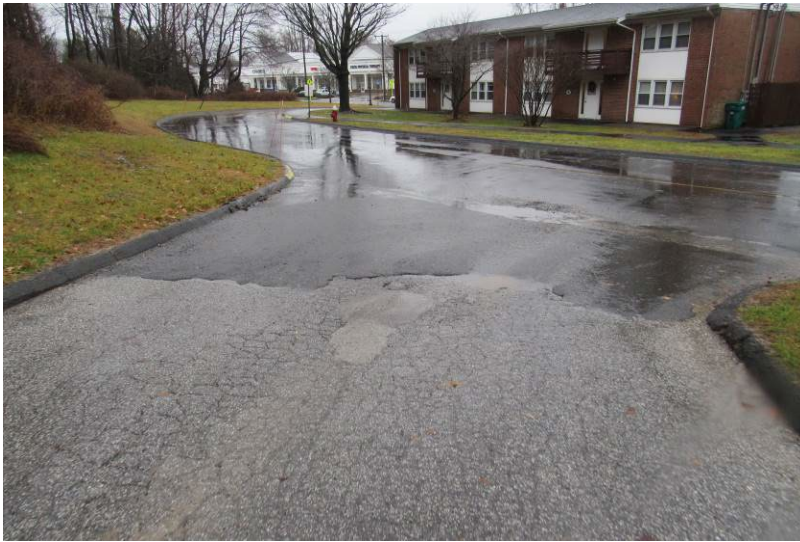
View of pattern cracking and evidence of fatigue within asphalt pavement as seen at entry roadway

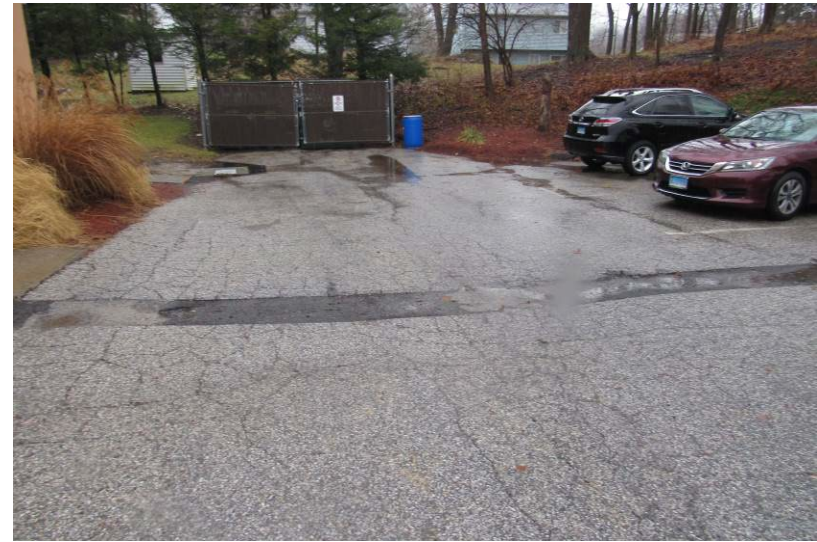
Additional view of pattern cracking/deterioration within asphalt pavement

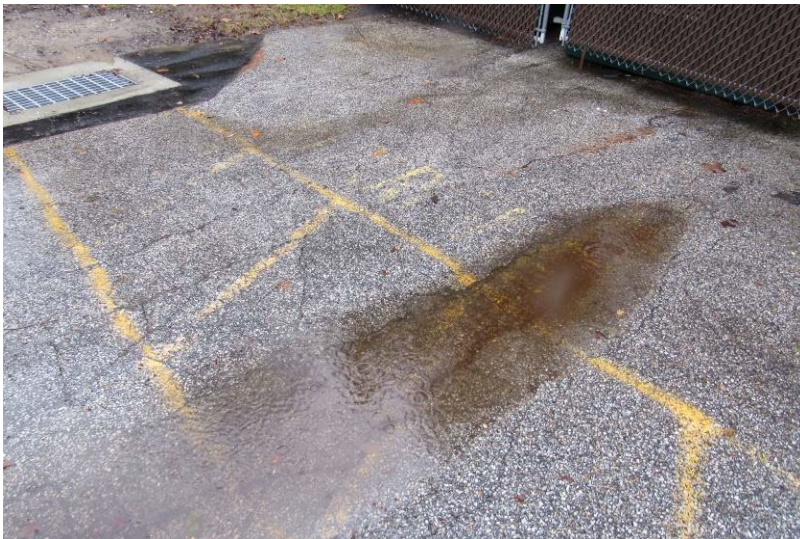
View of pronounced cracking/rutting within asphalt pavement as seen at dumpster enclosure approach – consideration should be given to installing concrete pavement to better withstand loads from waste removal trucks

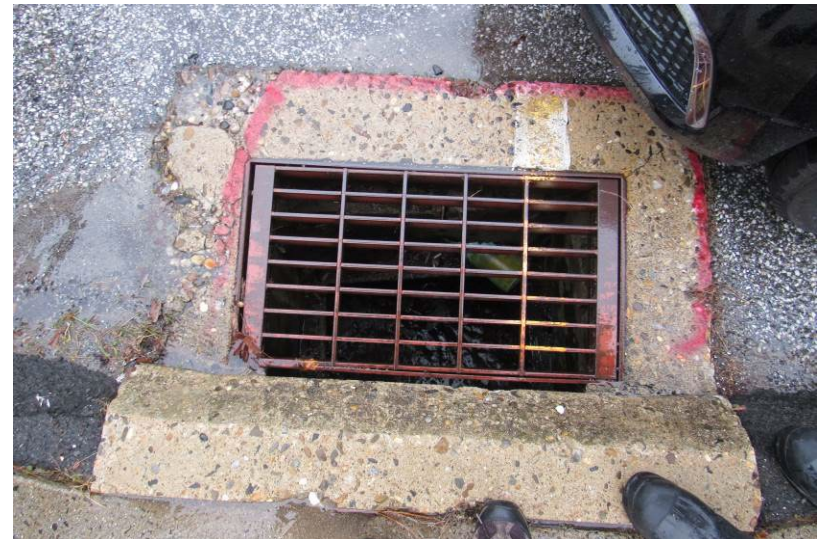
View of catch basin concrete collar exhibiting spalls/deterioration

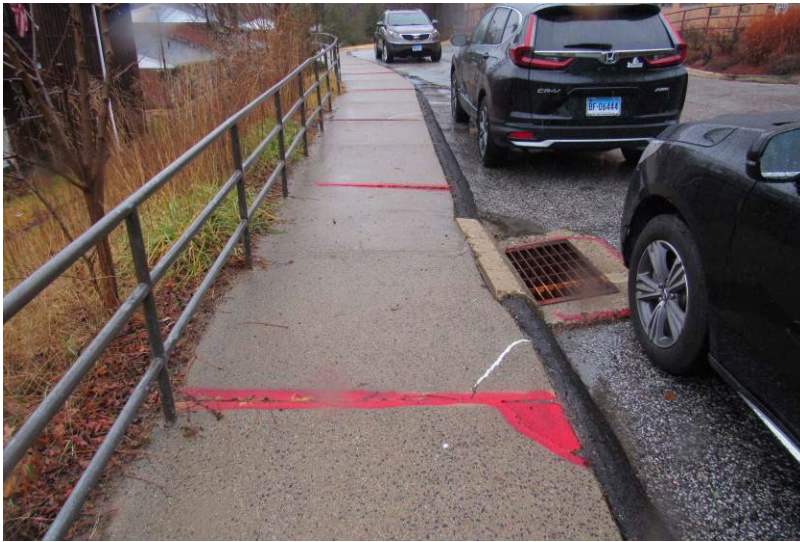
Several areas of unevenness and potential trip hazards observed within concrete flatwork

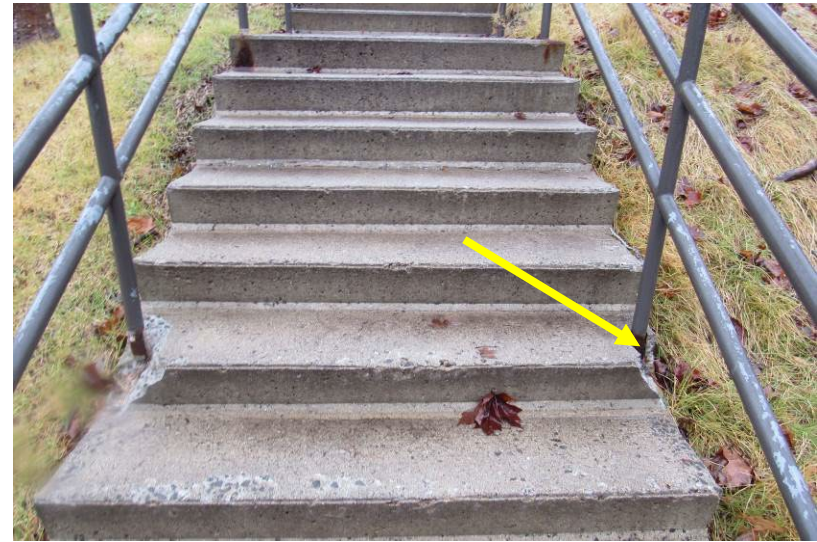
View of concrete steps and railings providing access to bus shelter – concrete spalls and corrosion of metal railing connections observed

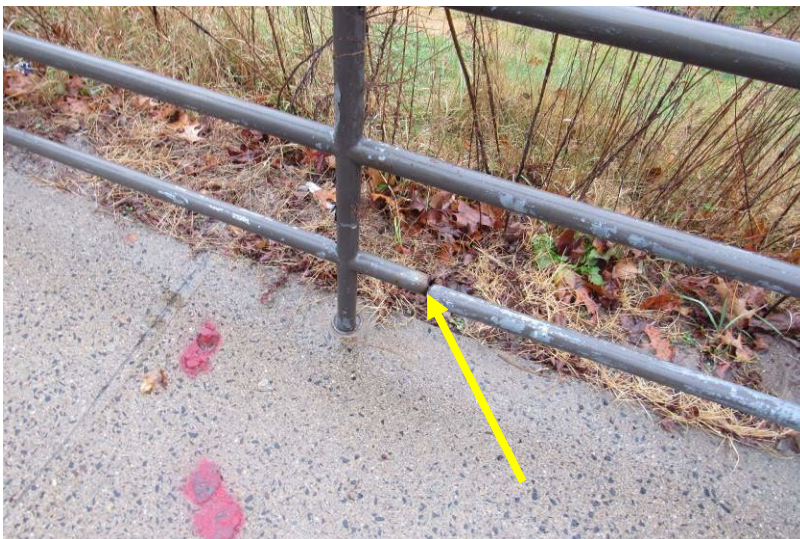
View of section of metal railing at walkway leading to bus shelter/Simeon Road exhibiting damage/wear

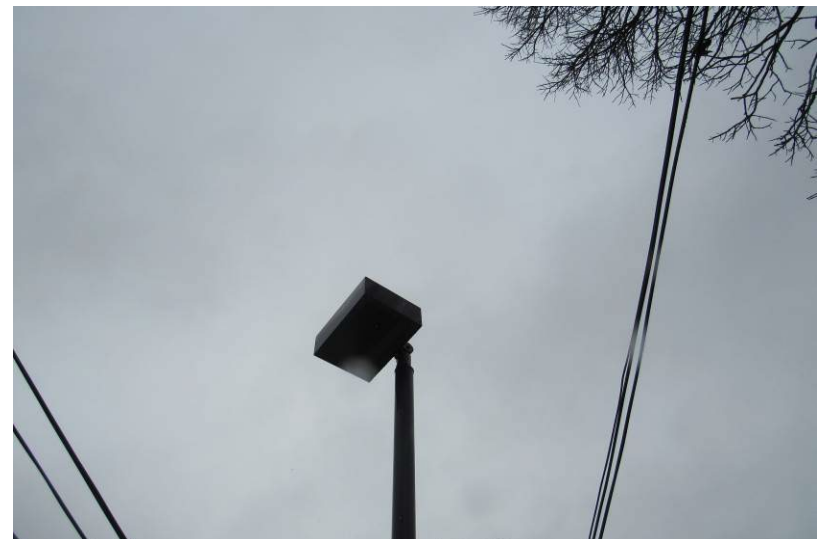
View of typical pole-mounted high intensity discharge (HID) light fixture facilitating site illumination – several light poles exhibit corrosion/weathering

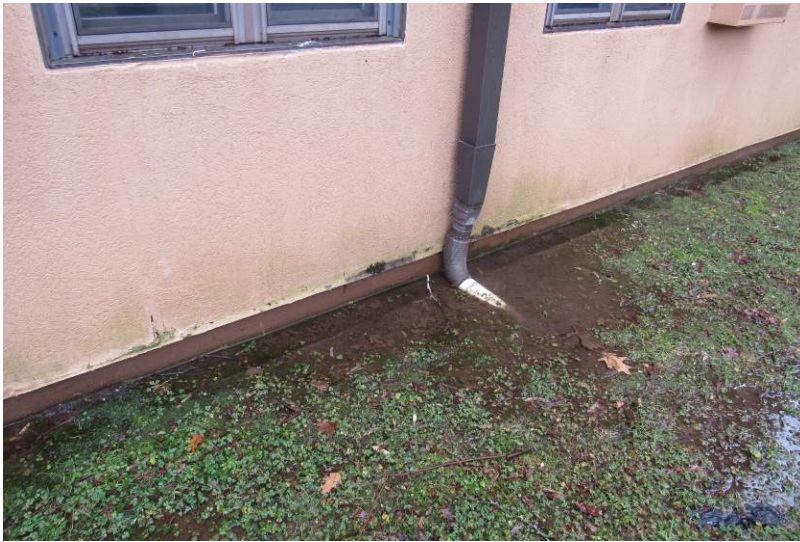
View of rear of building – reportedly poor drainage occurs along portions of this perimeter and may be conducive to water infiltration issues reportedly occurring at ground floor level

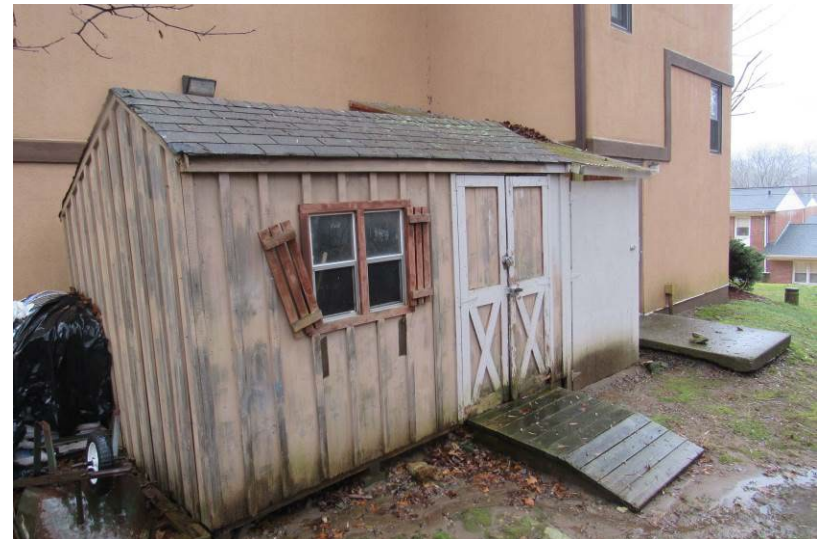
View of wood-framed storage shed located at north end of building – age related wear

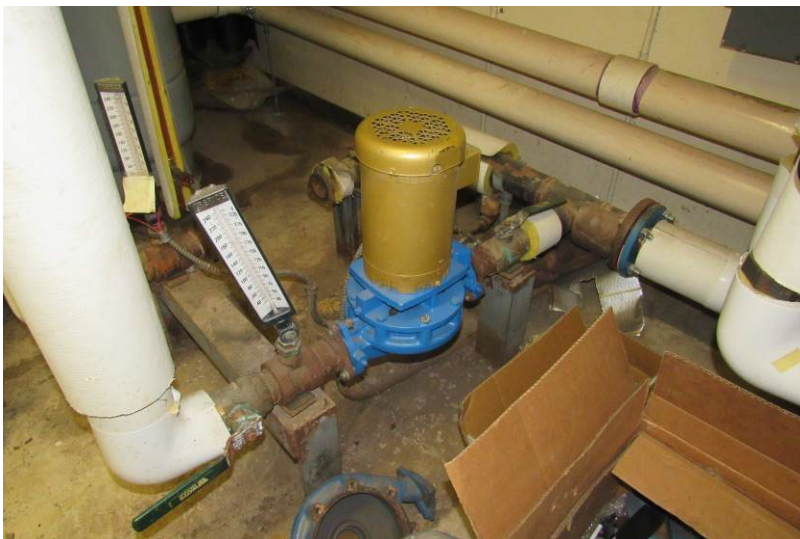
View of vertically-mounted hydronic heat circulation pump, 2-horsepower rating, 86.5% efficiency – motor replaced in 2021 and pump reportedly rebuilt; second pump requires replacement (difficultly obtaining quotes reportedly by management)

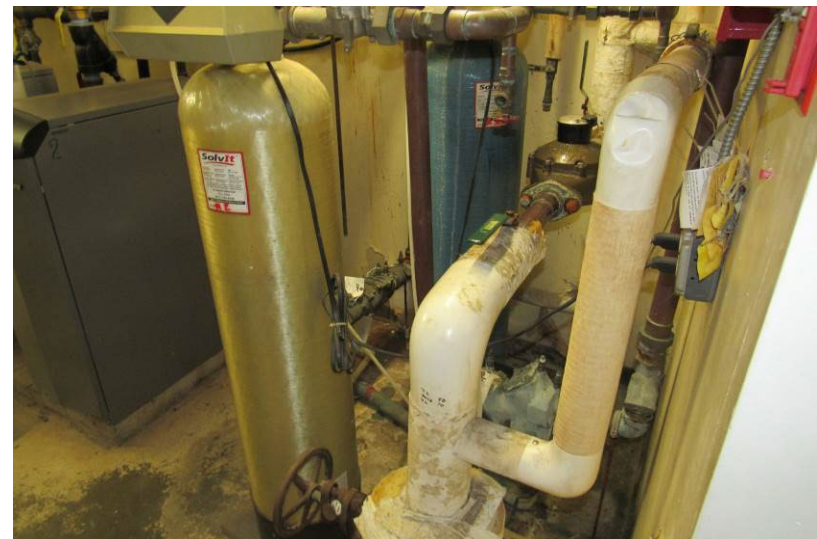
View of water softening system serving development – currently offline for several years

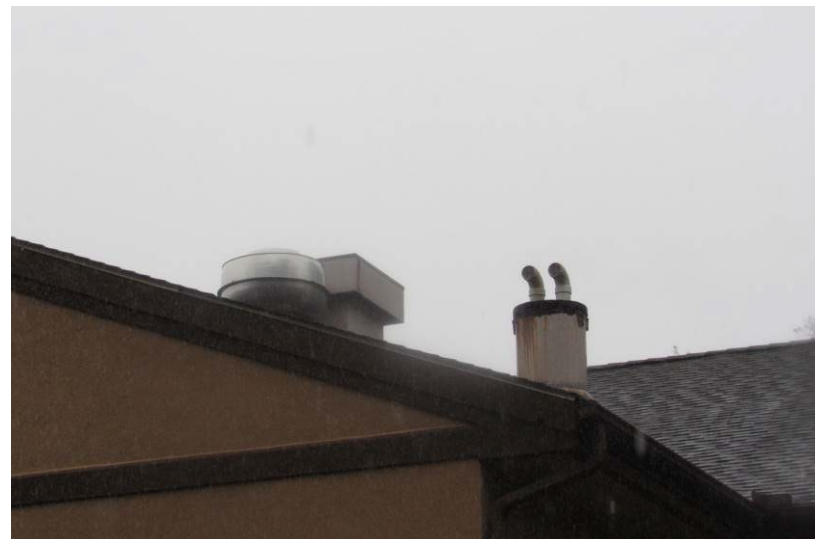
View of boiler flue exhaust; note flues appear to be in close proximity to commercial kitchen ventilation equipment; this condition should be further reviewed and addressed as may be required (i.e., ensure flues are appropriately distanced from kitchen air intake system)

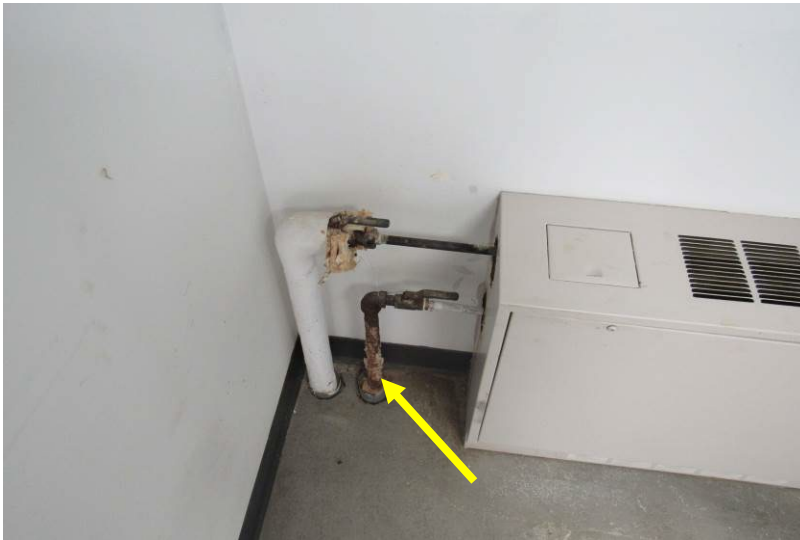
View of pronounced corrosion of hydronic heat copper distribution piping as seen at stairway cabinet heater – sections of distribution piping have been replaced in the past due to failure (common areas and apartment units)

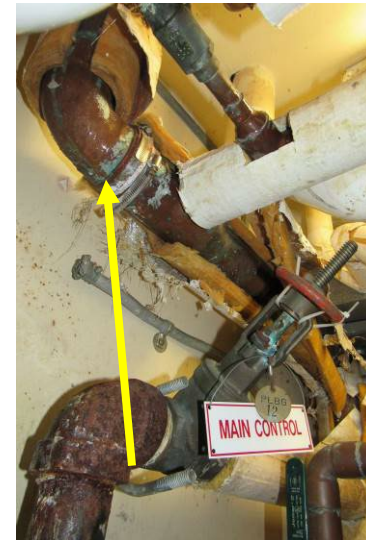
Active domestic water supply piping leakage issues occurring within boiler room

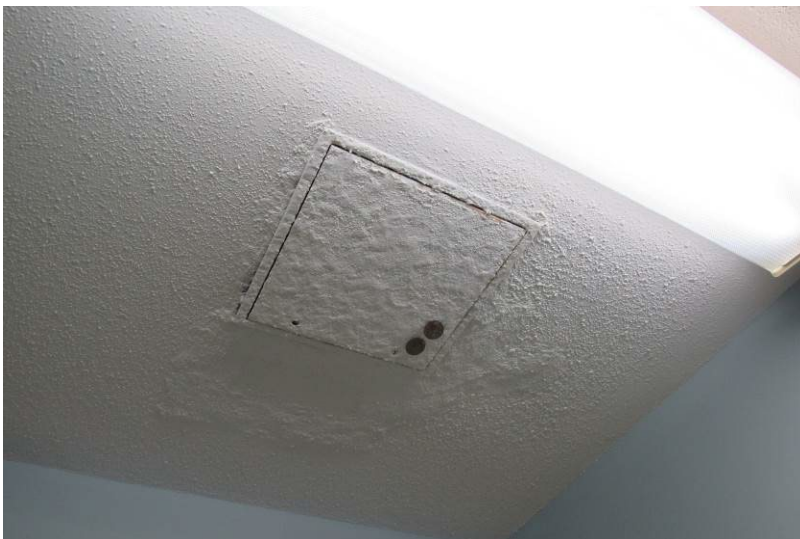
View of finished ceiling apparent moisture damage due to distribution piping failure as observed at ground floor level

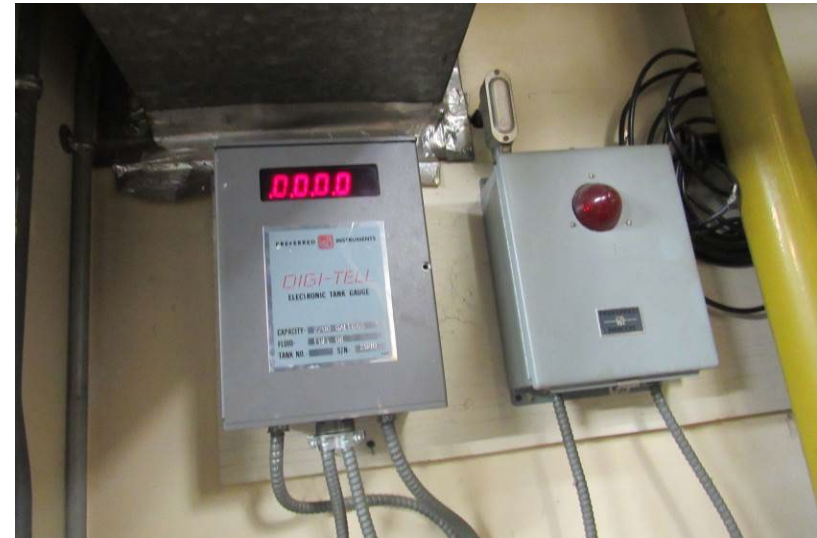
Emergency generator fuel gauge monitor reportedly problematic/not functioning

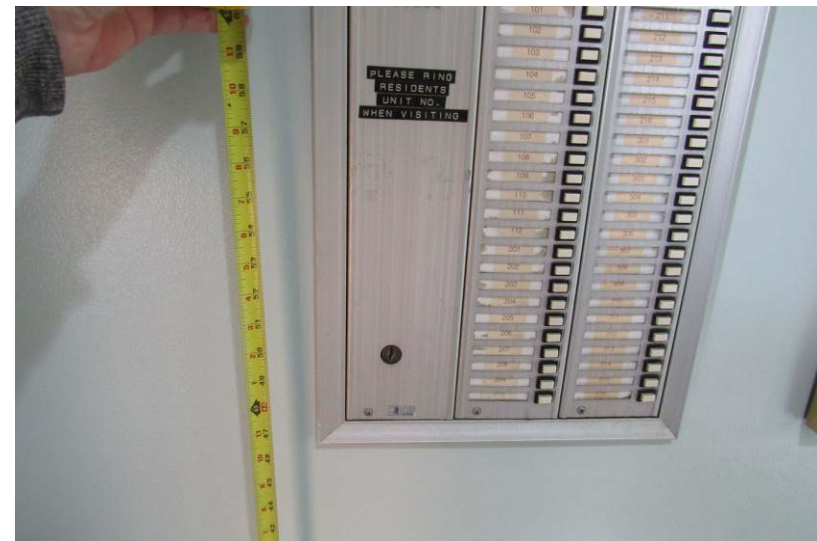
- The entry intercom panel exceeds reach range limits (i.e., select push buttons exceed 54-inches in height from the floor surface). These conditions are shown being addressed as part of planned intercom replacement shown in the Building Electrical section of the report.

View of entry intercom system regulating visitor entry into building – note select push buttons exceed acceptable UFAS reach range limits

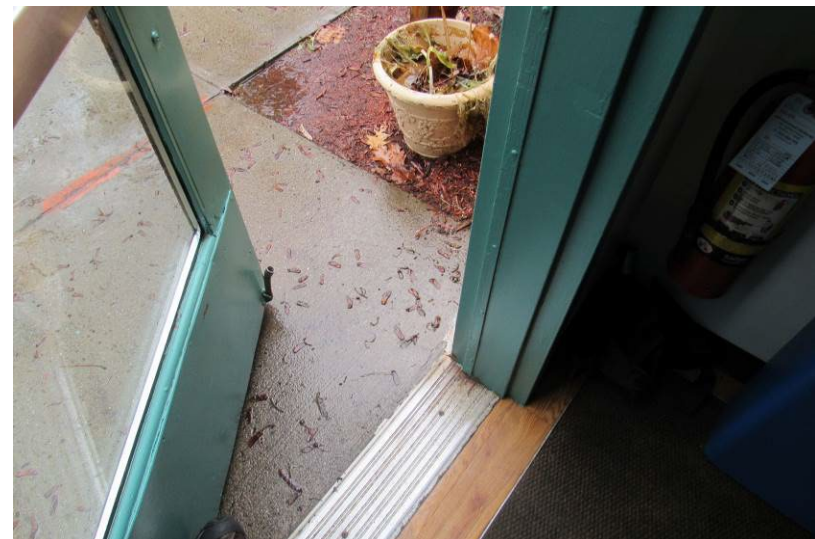
Majority of exterior doorways exhibit corrosion at door frames, abrasions, and finish wear

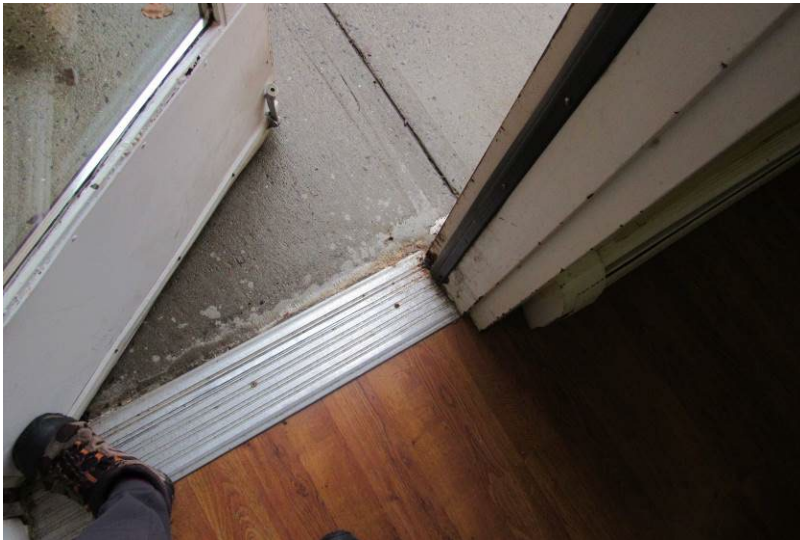
View of emergency egress doorway exhibiting age related wear

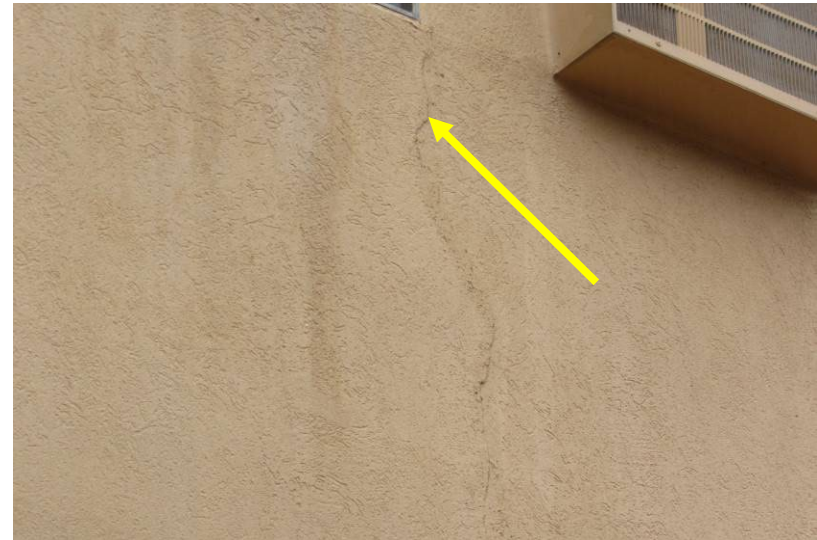
Several areas of cracking observed within EIFS cladding

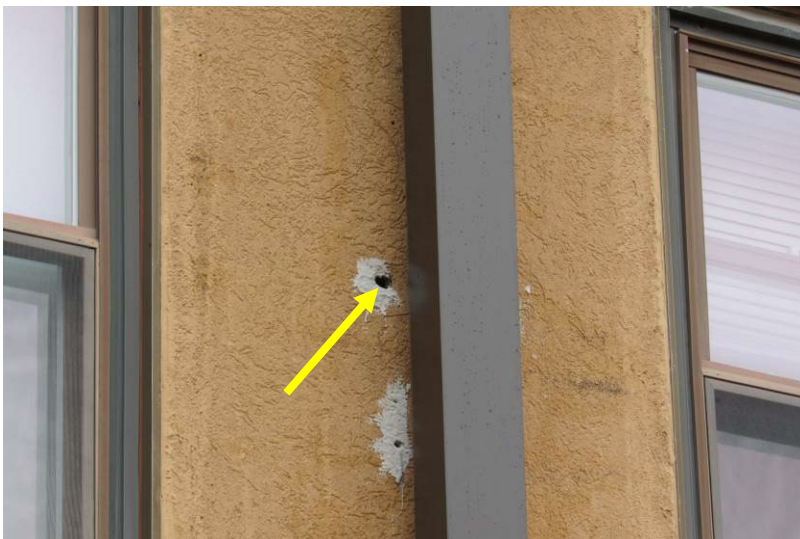
View of voids within exterior insulation and finish system (EIFS) as seen at front elevation – these areas are susceptible to moisture infiltration and subsequent damage to underlying building components/materials

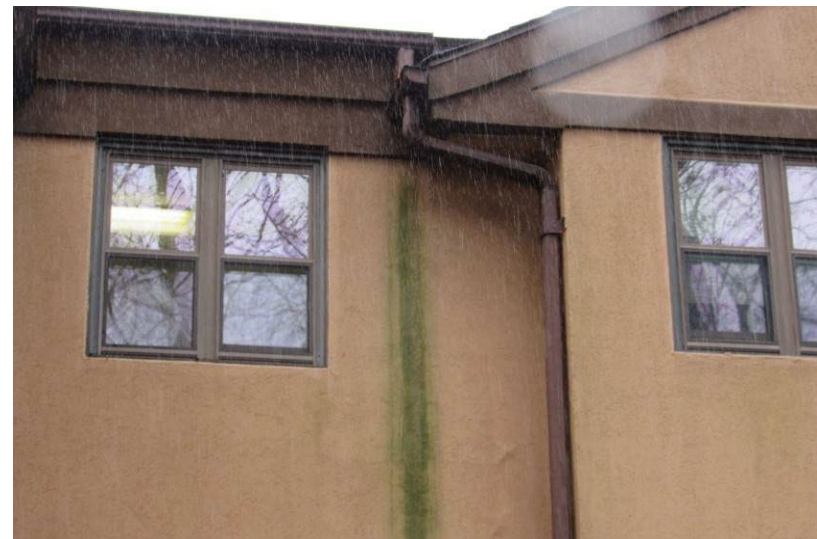
View of discoloration/moisture staining on EIFS cladding as seen at rear of building – appears to be due to failed downspout/gutter

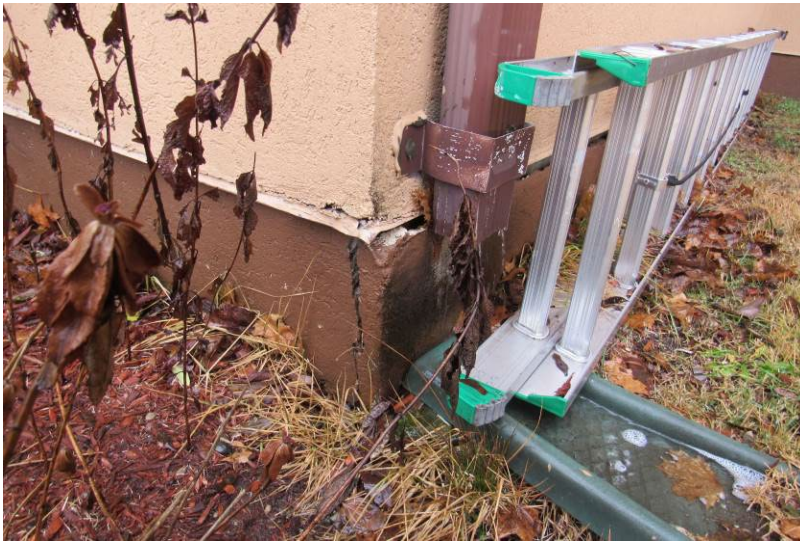
View of apparent displaced section of concrete foundation wall cementitious parge coat as seen at front of building

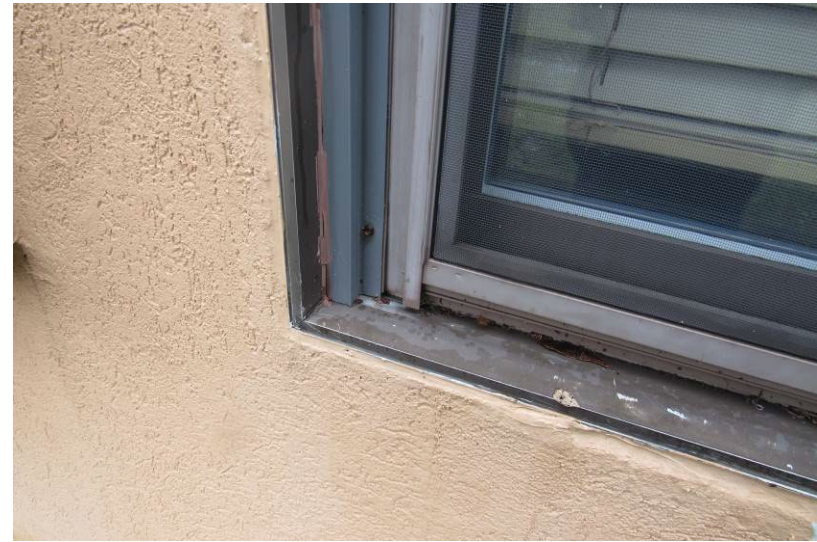
View of deteriorated exterior caulking at window perimeter (cohesive/adhesive failures)

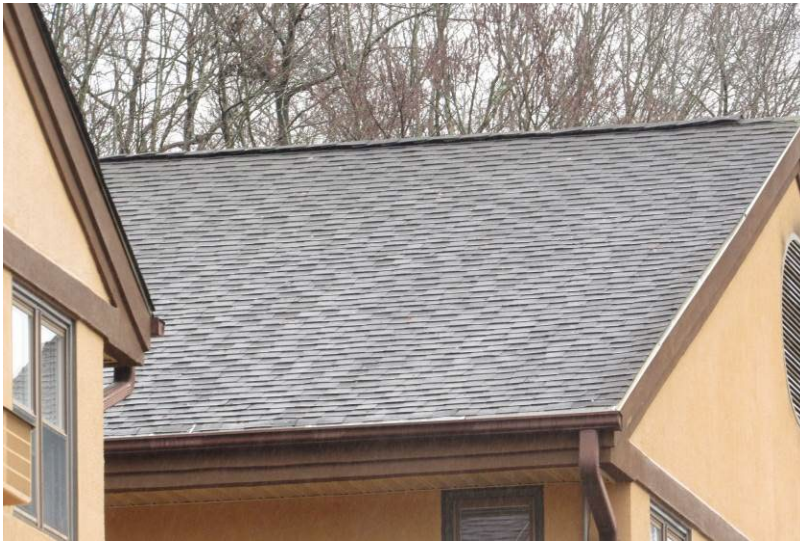
View of architectural asphalt roof shingle conditions as seen from available vantage points – active roof leakage reported at east end of building

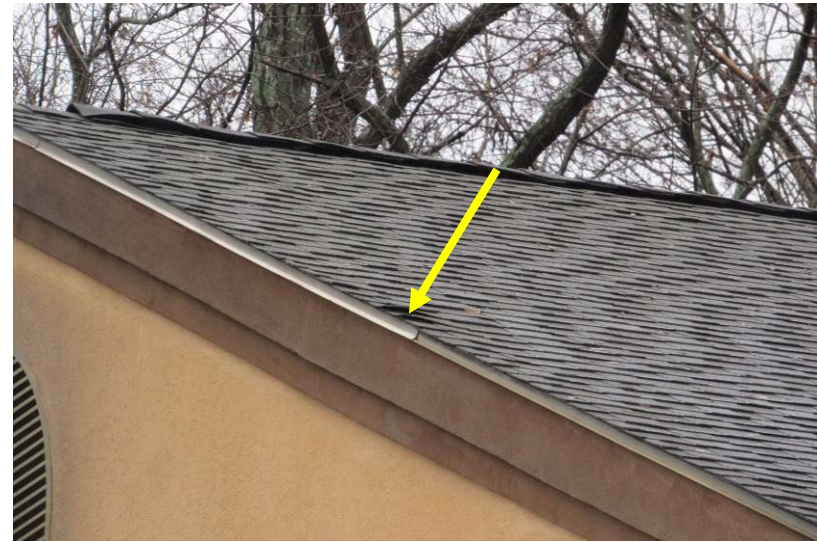
Isolated curled/uplifted shingles noted from available vantage points

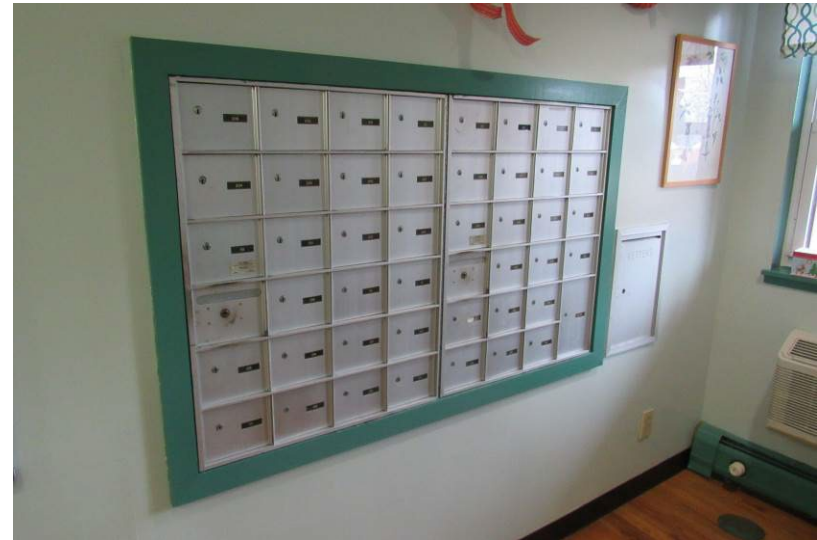
View of recessed aluminum mailboxes – mailboxes are reportedly original; dividers are problematic

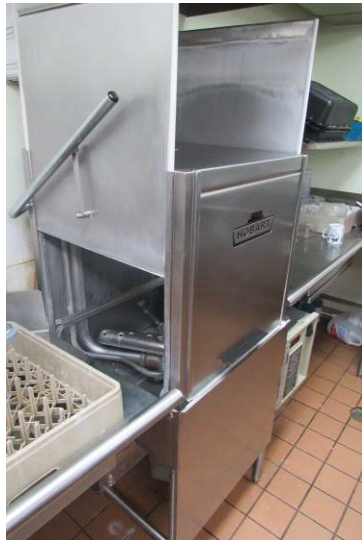
View of sample of commercial-grade kitchen equipment – note dishwasher is reportedly problematic
