Capital Needs Assessment

PRELIMINARY REPORT

**Augustana Bishop Curtis
Congregate**

December 29, 2023

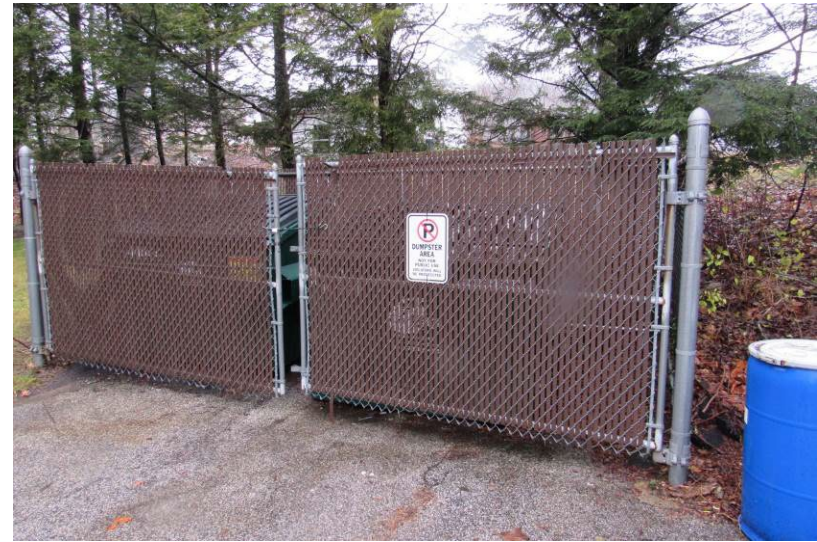
View of metal chain-link dumpster enclosure

Replacement costs are shown in Year 1, concurrent with walkway/ramp/site step repairs/replacement (including as-needed accessibility improvements). A metal chain-link dumpster enclosure is present at the rear of the property. Future replacement costs are shown in Years 3 and 18. The rear metal wire fencing exhibits age related wear/weathering; replacement costs are shown in Year 1.

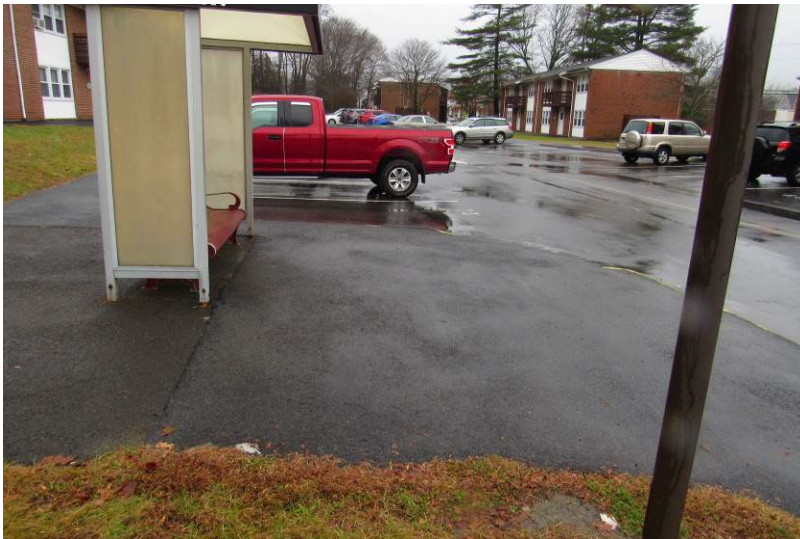
View of bus shelter located west of development – shared with abutting family property

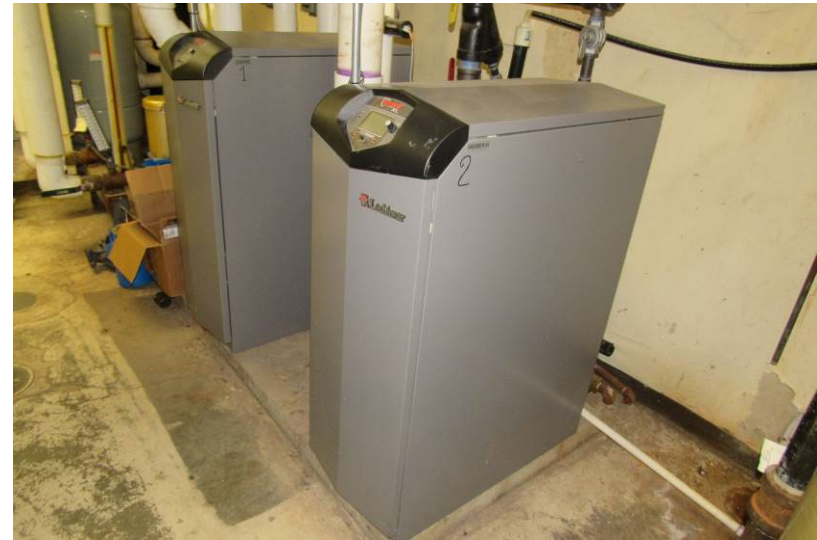
View of Lochinvar natural gas-fired condensing boilers facilitating hydronic heat generation for building – 500 MBH energy input each

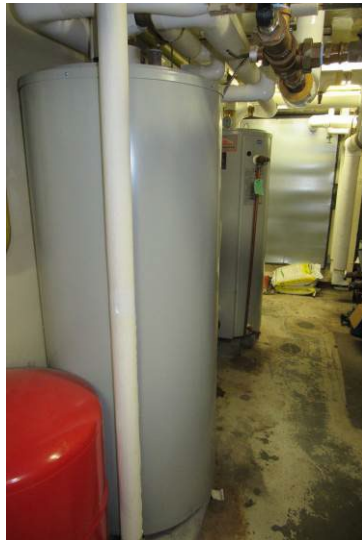
View of indirect-fired domestic hot water (DHW) storage tanks – 119-gallon storage capacity each

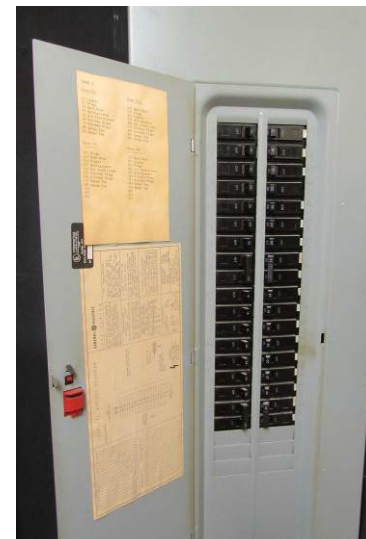
View of typical General Electric circuit breaker panel serving bank of 4 apartment units

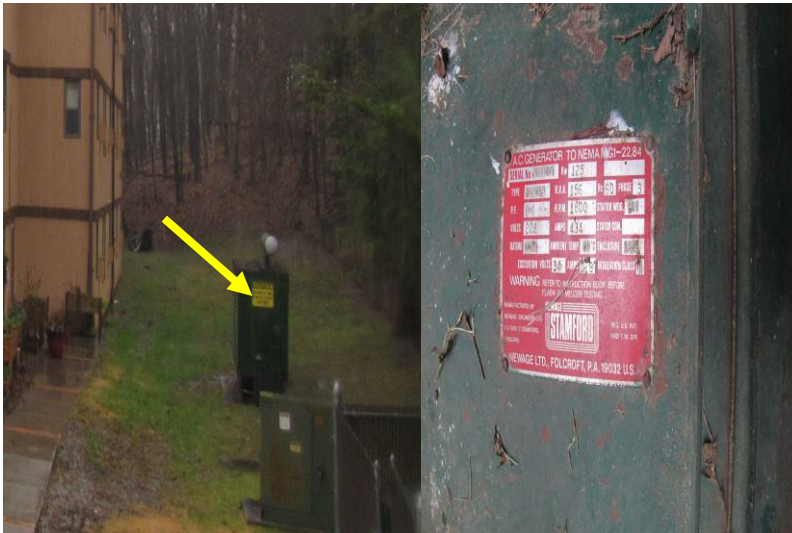
View of diesel-fueled emergency generator present at rear of building and serving key building systems in the event of a power failure – 125 kW rating – diesel fuel is stored in a 2,000-gallon underground storage tank

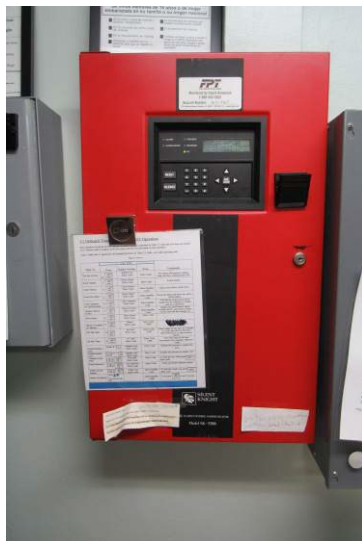
View of Silent Knight SK-5208 fire alarm control panel monitoring hardwired end devices at building

- Development interior common areas lack visual warning strobes (e.g., common restrooms, laundry rooms, office space, community room, lounges, etc.). These conditions are shown being addressed as part of planned fire alarm system replacement shown in the Building Electrical section of the report.

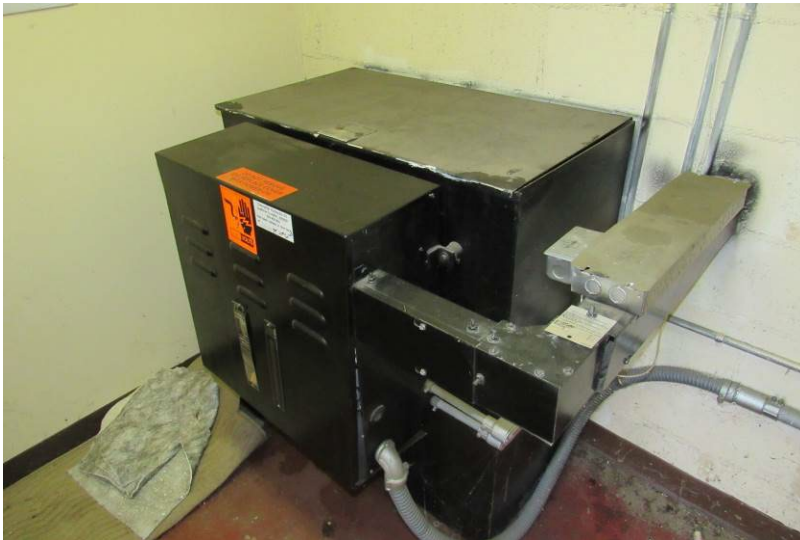
View of elevator machine room equipment – maintained under the terms of a full service agreement

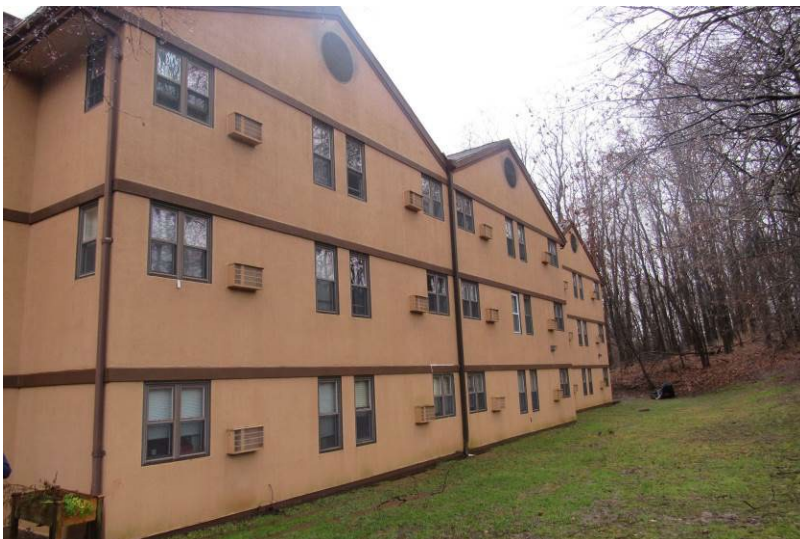
View of typical building architecture as seen at rear of building – note exterior insulation and finish system (EIFS)

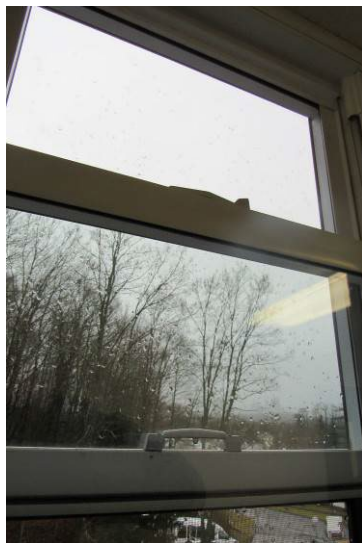
Exterior windows are vinyl-framed double-hung models containing insulating glass units (IGU's) – no widespread failed or cracked IGU's noted during the assessment; isolated windows replaced in past due to water infiltration issues

The exterior windows appear to have been replaced since original construction (exact age unconfirmed but are estimated to be approximately seventeen years of age). Future replacement of the vinyl-framed windows is shown in Year 9, based on a twenty-five-year expected useful service life. Interim costs for as-needed replacement of failed and cracked insulating glass units (IGU's) are shown in Years 1-8 (failure of an IGU is ultimately apparent when condensation forms between the glass panes). Management reports select windows are difficult to operate by tenants; these windows are shown being addressed out of operating accounts. Future replacement of the awning installed over the south end patio is shown in Year 14 (recently replaced). Replacement of the building-mounted HID and CFL fixtures is shown in Years 1 and 16, based on a fifteen-year expected useful service life; consideration should be given to installing light-emitting diode (LED) fixtures at these locations as an energy efficiency improvement.

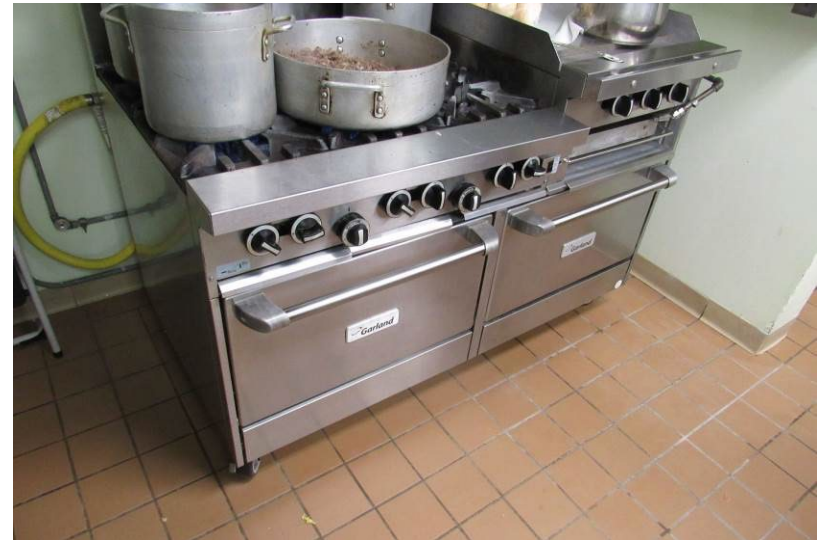
Additional view of commercial-grade kitchen equipment

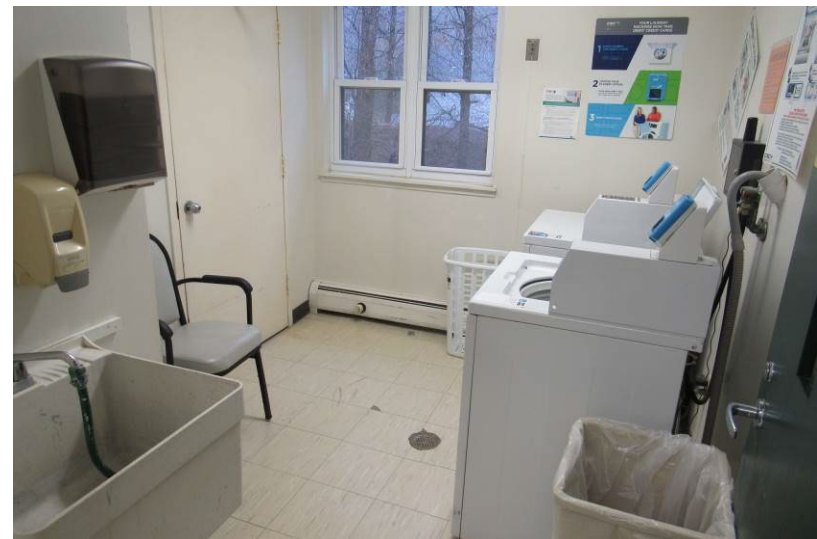
View of typical laundry room finishes and equipment – washer/dryers are reportedly leased

- Laundry room deficiencies include non-compliant sinks (i.e., lack of adequate front apron clearance), lack of 18-inch maneuvering clearance at the latch side of the entry doors (sinks currently an obstruction to maneuvering clearance), and select laundry rooms lack front-loading washers (request front-loading washers from vendor).

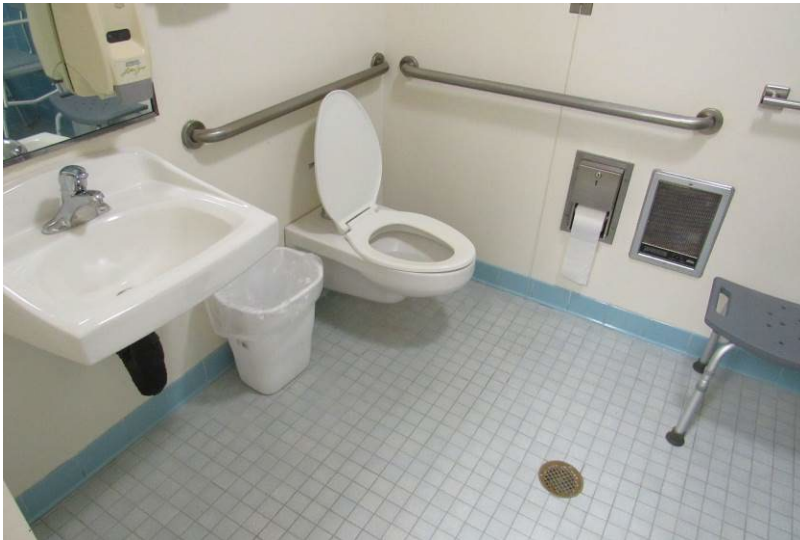
View of typical common restroom finishes and fixtures (1 of 5 total restrooms present at development – 3 contain shower stalls)

- The development contains five common restrooms (one on 3rd and 2nd-floor levels, three on 1st-floor level). Deficiencies include lavatory piping is not fully insulated, select lavatories require repositioning to facilitate 29-inch front apron clearance (e.g., 2nd-floor and ground floor restrooms), toilets are not distanced 18-inches centerline from the near wall, toilet rear grab bars are not distanced 6-inches from interior corner (1 of 3 ground floor restroom rear toilet grab bars is not a minimum length of 36-inches), select toilet side grab bars are not distanced 12-inches from the interior corner (e.g., 3rd, 2nd, and 2 of 3 ground floor restrooms), select toilets are not distanced between 17-19-inches high from the floor surface (e.g., 1 of 3 ground floor restrooms), shower faucets are knob-style and require twisting of the wrist to operate, and select paper towel dispensers exceed 54-inches in height from the floor surface.

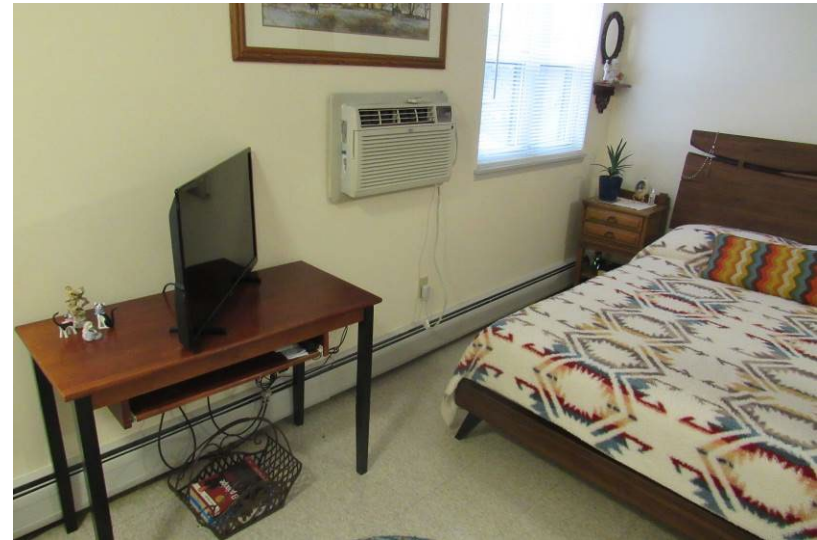
View of typical unit living area finishes – note air conditioners are tenant responsibility; majority of VCT flooring is original/older

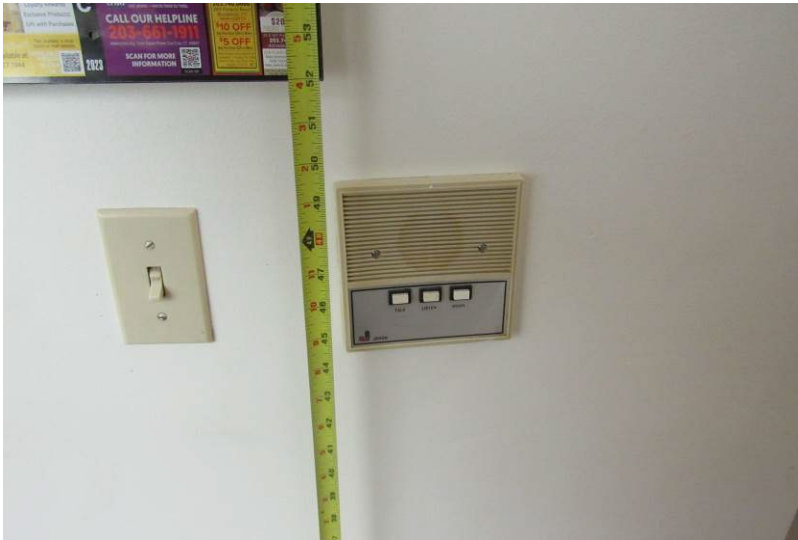
View of unit-level intercom panel regulating visitor access into building – positioned within acceptable UFAS reach range limits
